ATLANTIKWALL

D-Day 1944 - 2014 David Maes

The German coastal battery of Longues-sur-Mer (WN 48)

The German coastal battery of Merville

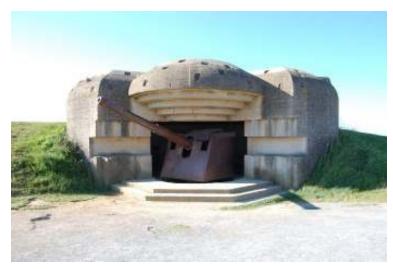
The landing beaches in Normandy. The battery of Longues-sur-Mer is situated north of Bayeux. (Source: Marriott & Forty: page 14)

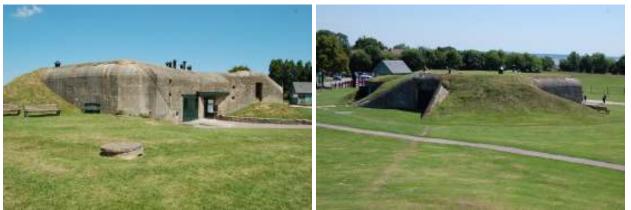
The command bunker was an adapted Regelbau 502. This is where Sergeant-Major Buskotte would receive his orders from Lieutenant Steiner by phone. From the command bunker there was also a phone connection with the four combat casemates. The largest of them is a Regelbau 611. To build such a combat casemate 1.330m³ of concrete and 80 tons of steel was needed. In 1986 when Steiner and Buskotte visited the battery they noticed the bunker was sunk to a large extent. Combat casemates 3 and 4 are Regelbauten 612 while combat casemate 3 is a Regelbau 669 with the particularity to have a cellar. These 3 casemates were built urgently between February and May 1944.

The battery's command post where Sergeant-Major Buskotte received his orders from Lieutenant Steiner and transferred them to the combat casemates.

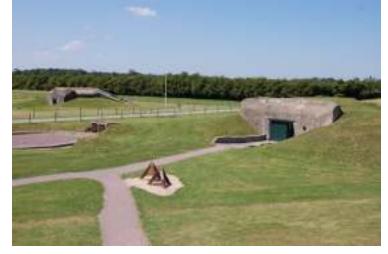
In 1998 four large initially built concrete open emplacements were found, one behind each combat casemate, built to replace the open emplacements. The Germans would have covered them permanently after building the casemates between April and June 1944 because they could be observed too easily from the air by hostile aircraft.

Casemate 3 and 4 with still visible the initial open emplacement.
